The Basic DISK II Pages Common Mistakes and Damages to Disk II Controller or DISK II Drives **project**

The DISK II Drive - a classic storage system

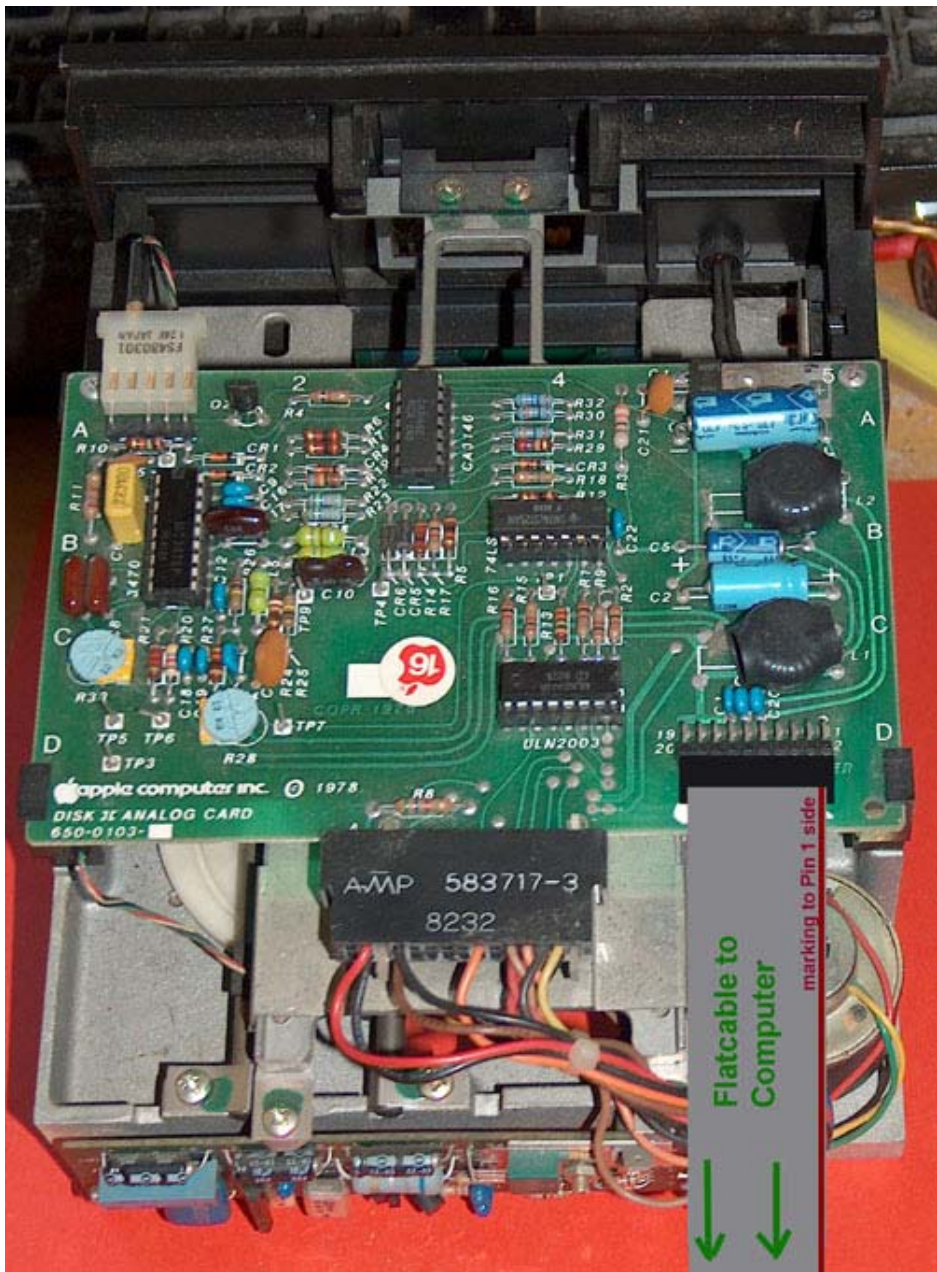
Pay careful attention to the flatribbon cable at the right bottom corner of the picture marked as "Flatcable to Computer" ! recognize at the PCB-Connector where the cable is connected to at the left side of the plug the marking "19" and "20" while at the right side of the plug there is the marking of "1" and below "2" ! Along with the different series of drives the Flatribbon cables have been in the early days so called "rainbow color cables" (having all the colors also used for indicating numerical values at resistors) and later being replaced and distributed with grey colored flatribbon cables (sometimes with attached mounting flaps). Regardless which cable has been used : You shall mark the side at which the wires of pin"1" and pin "2" run along - and you must mark the cable at BOTH ends (also that end where you want to plug the cable to the interface) !!!

In case the plug has an arrow symbol pressed in the plastic (like indicated in the right picture with red marking arrow) make sure - that this really indicates at both sides of the flatribbon cable the side of the cable containing pin "1" and "2" ! If the marking is wrong - then at least mark up the plug correct with permanent marker writing or with "heavy duty label " (not so easy to remove)

**Precaution: if you buy a DISK II from any unknown source (you don't reallyly know the seller by yourself in person)
then it's strongly recommended to check out the cables by yourself and inspecting if everything is correct !**

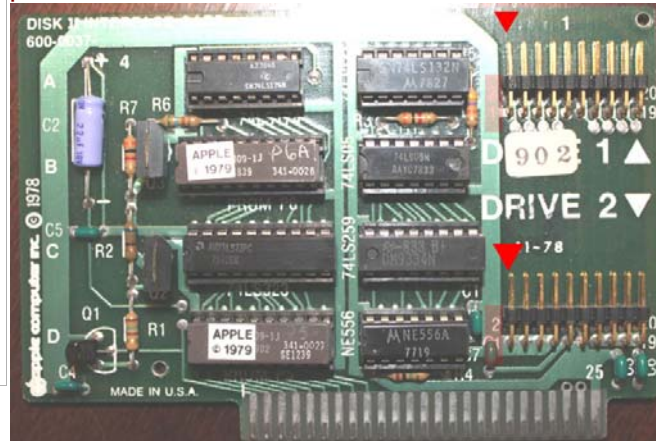
At the left side i display also a very common mistake: **Missaligning the plug of the cable at the controller or at the analog board by leaving the bottom row of pins unused and plugging the lower holes of the plug to the top row of the pins.** This is same harming as the mistake by twisting the sides of the cable and plugging pins "1" and "2" of the analog board to pins "19" and "20" at controller side or vice versa !

Both mistakes will cause same result: Because the "analog Board" gets wrong voltages of the supply to the board **you will "fry" the circuits on that analog board by making shortcuts or by connecting voltages with wrong polarity !**

In both cases you must afterwards test and change the IC's at the board - if you are lucky... if not - you might have "fried" parts of the interface or the Apple itself ! (In case you did not immediatly shut off Apple again after malfunction.)

Be sure also when connecting cable to the interface to recognize the markings indicating the side related to pin "1" and pin "2" !

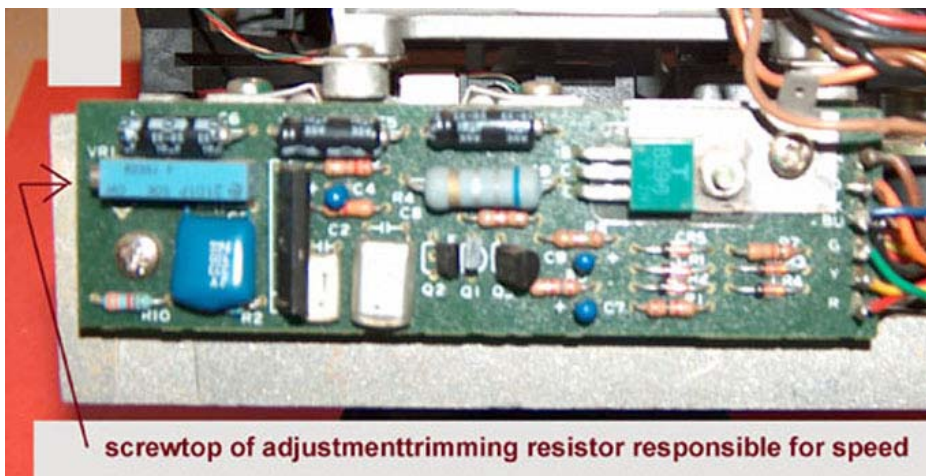
Motor PCB

screwtop of adjustmenttrimming resistor responsible for speed

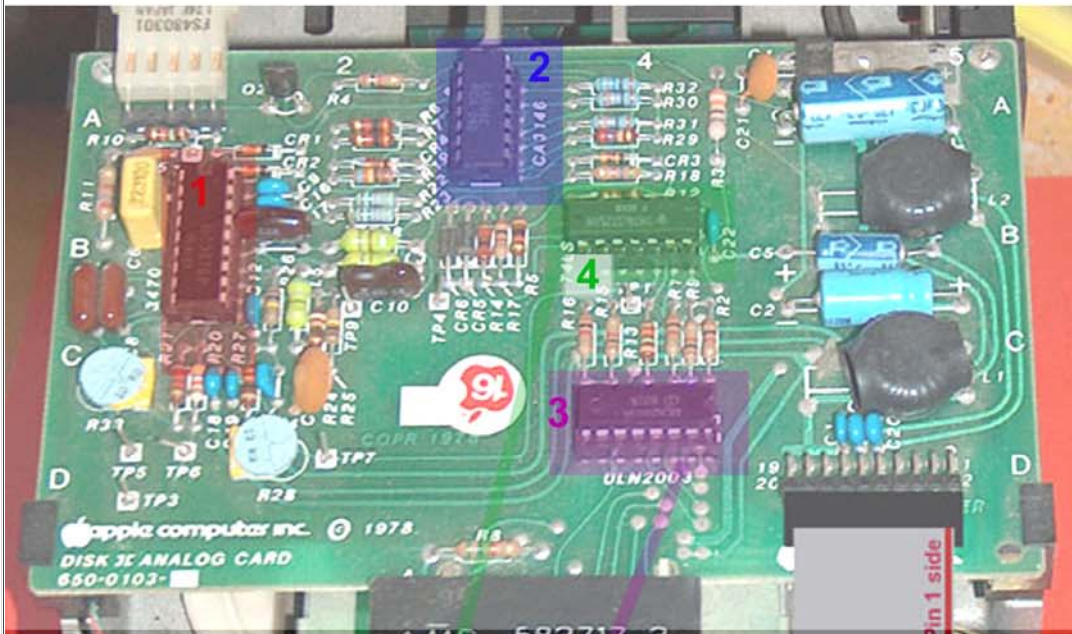
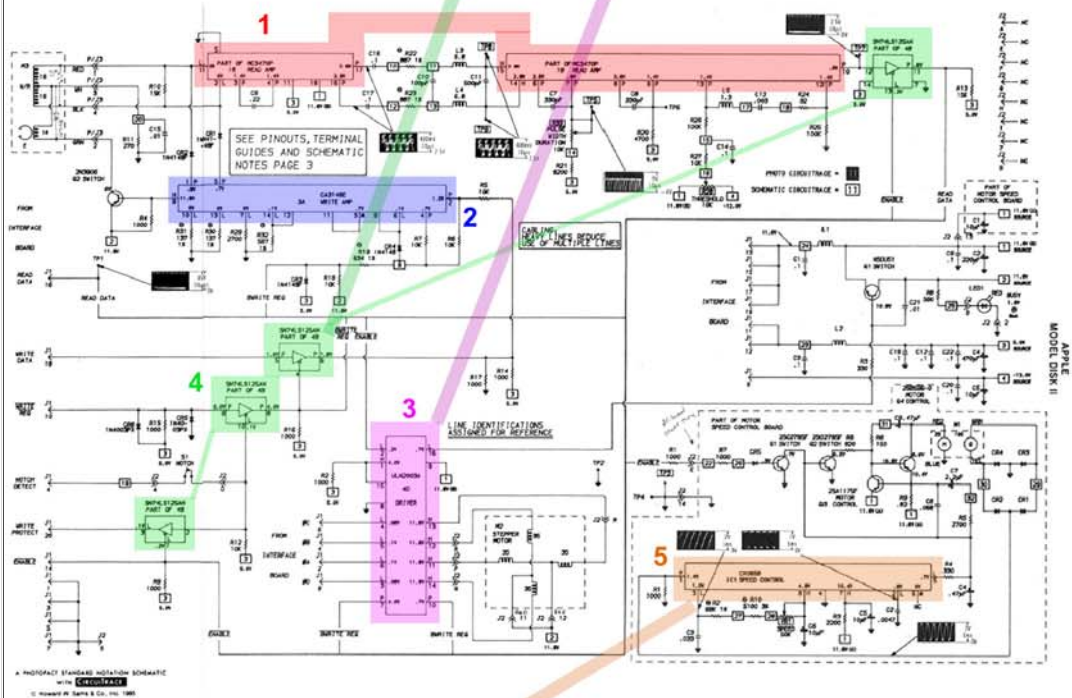
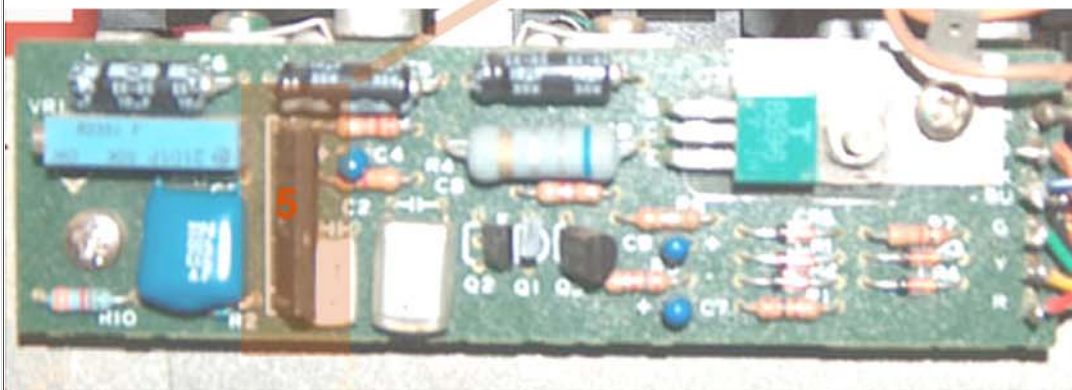
Allocation of ICs at PCB and at circuitplan

The Hitlist of damaged Circuits is in the order how fast this circuits will be killed at missalignment of the cables and a link to replacement part:

the chance that this chip has been killed is about 100% it's the first one that will be killed after about 5 to 10 seconds of power up Apple II with misaligned plugs.

the chance that this chip has been killed is about 70% it will be killed after about 10 to 20 seconds of power up Apple II with misaligned plugs.

http://www.ebay.com/itm/RCA-CA3146E-High-Voltage-Transistor-Array-IC-Hard-to-Find-Great-Price-Look/291161195723?_trksid=p2047675.c100011.m1850&_trkparms=aid%3D222007%26algo%3DSIC.MBE%26ao%3D1%26asc%3D23491%26meid%3D8386012611802024220%26pid%3D100011%26prg%3D10073%26rk%3D6%26rt%3D10%26sd%3D200288796205
the chance that this chip has been killed is still about 70% it will be killed after about 10 to 20 seconds of power up
Apple II with misaligned plugs.

http://www.jameco.com/webapp/wcs/stores/servlet/Product_10001_10001_1147178_-1
the chance that this chip has been killed is about 25% it will be killed after about 1 to 2 minutes of power up
Apple II with misaligned plugs.

This chip is nearly never killed because
before this happens you will have seen smoke coming out of the drive
while the other 4 ICs would have been fried and cooked !
If this chip is dead then there will be no correct speed control of the disk spinning motor.

If this chip must be replaced the read/write part of the PCB must be readjusted

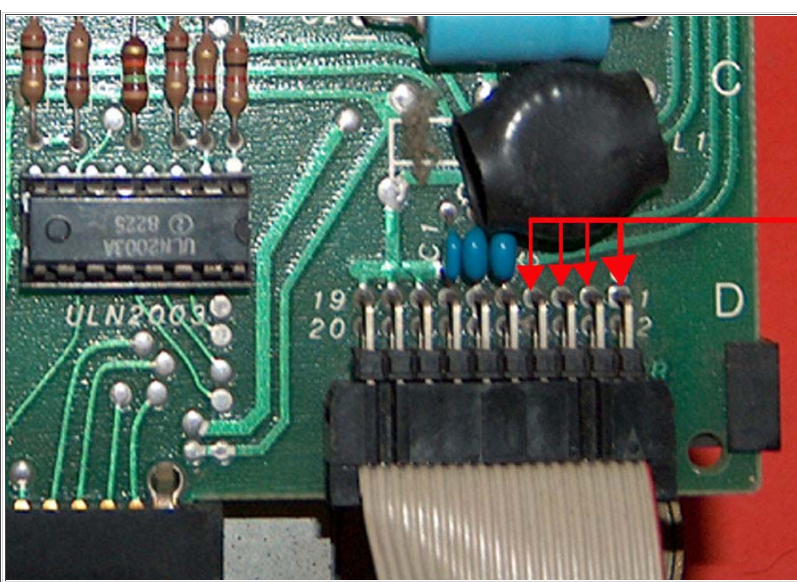
Hint to find Ground at the analog board: Pin 1,3,5 and 7 at the connector of the analog board to the plug of the cable to the interface are connected to Ground

closeup to pins of cablepost connected to Ground

solution: solder a flexible wire to the shielding plate and at the other end of the (rather short !) flexible wire mount a pin- connector and add (+close to the large filtering capacitors at the

analog bord at their minus pol (which is the general ground of the drive) a pin where that wire connector may be attached to....

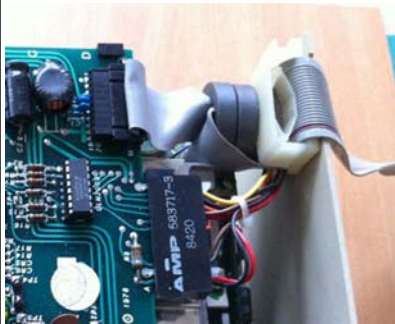
<= This left picture shows the better grey partially shielded cable mounted correct with 2 turns in the inductive core.

that inductive core shall be mounted and the cable should make 3 turns through that core and be mounted between the analog board and the fixing clamp at the rearside of the case !

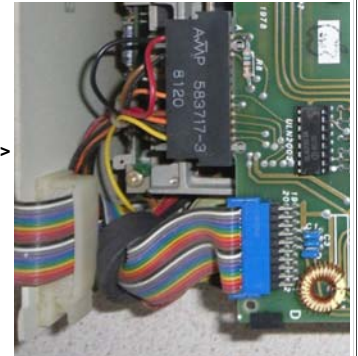
this right picture displays the older => not so good "rainbow" cable and it also displays mistake: the cable runs straight through the inductive core without windings !
