## The Basic DISK II Pages

### Speedadjustment **project**

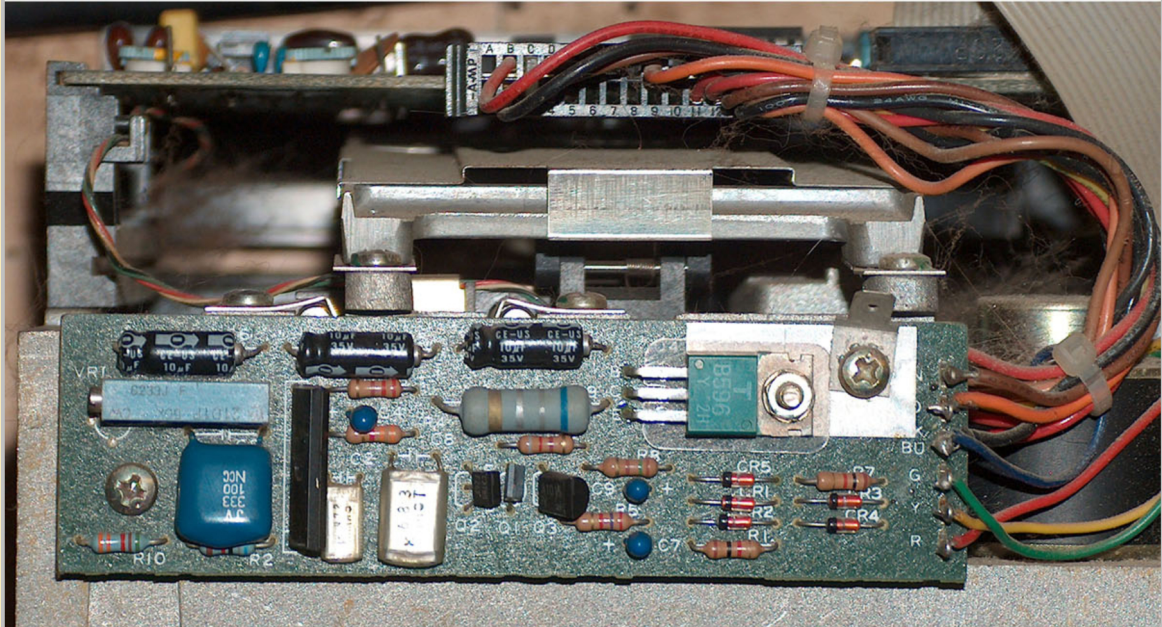
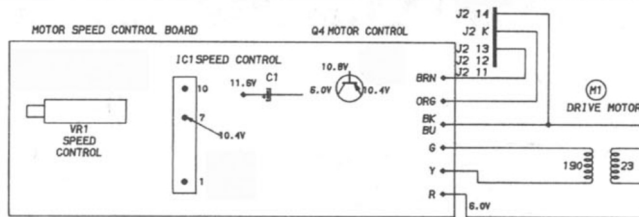
The drawings below also indicate some values of voltages and the points where they should be measured.

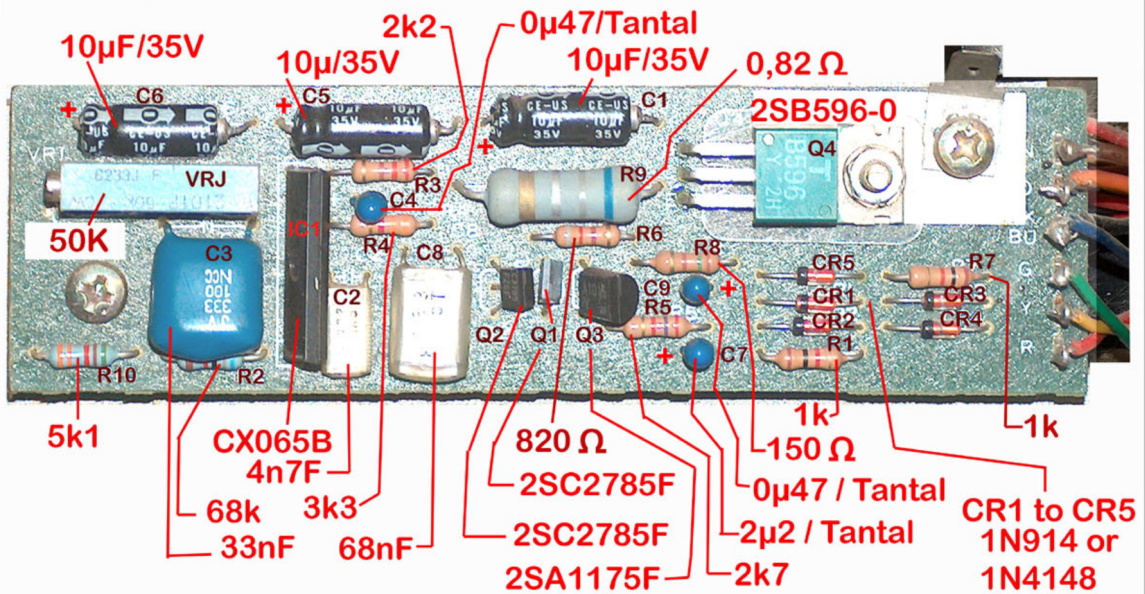
## Component Values

The affected capacitors are: C1, C5 and C6. In the picture at the bottom of the page the values of that capacitors are displayed.

In even more rare cases the foil capacitors might have drifted of the demanded values. That would be related to the capacitors C2 and C8.

Due to age in very rare cases it might turn out to become required to "recap" the electrolytic capacitors of the speed-control board.
