The Basic DISK II Pages

the write protection and modifications of the write protection project

The DISK II Drive - a classic storage system

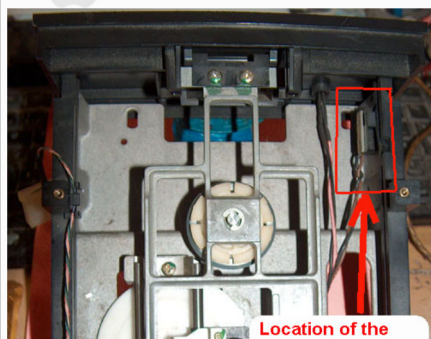
In the classic DISK II drive of Apple the detection was performed by a microswitch that was located here:

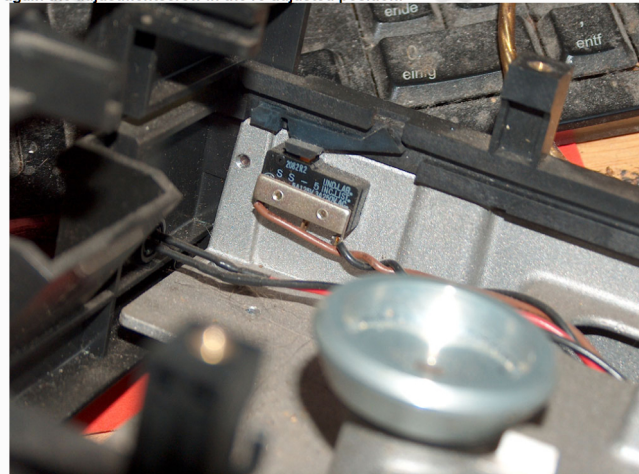
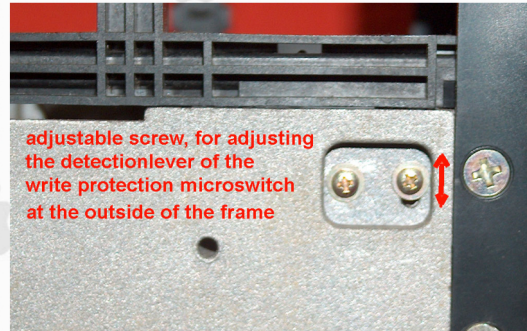
The pictures below show at left a closeup of the microswitch and the detection lever and at the right picture the opposite (outside) of the steelframe is displayed to show the adjustment-screw. In case of malfunction of the write protection often the lever is misaligned and by untightening the adjustmentscrew the switch with the lever can be adjusted again in a position where the switch surely indicates again the presence of a notch or it's absence. Then the user can tighten again the adjustmentscrew in the re-adjusted position.

adjustable screw, for adjusting the detection lever of the write protection microswitch at the outside of the frame

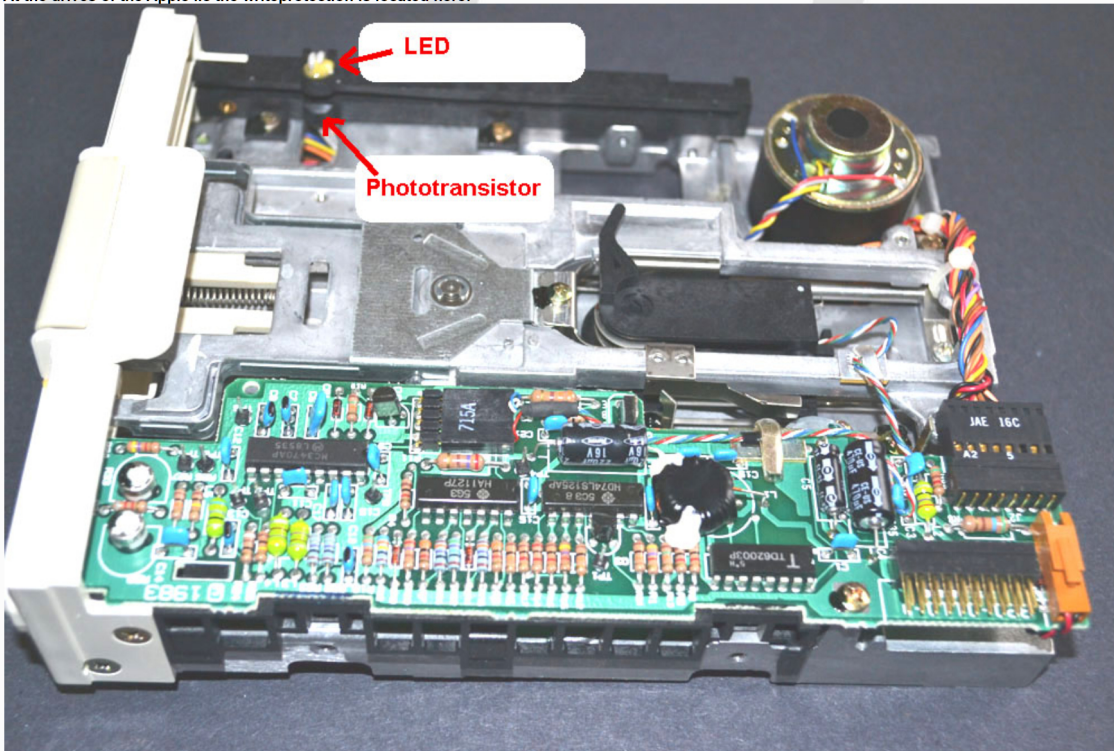
At the drives of the Apple IIC the writeprotection is located here:

LED

Phototransistor

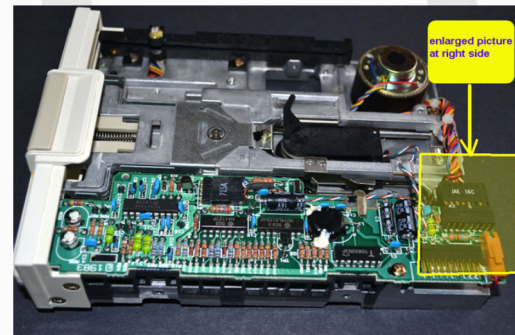
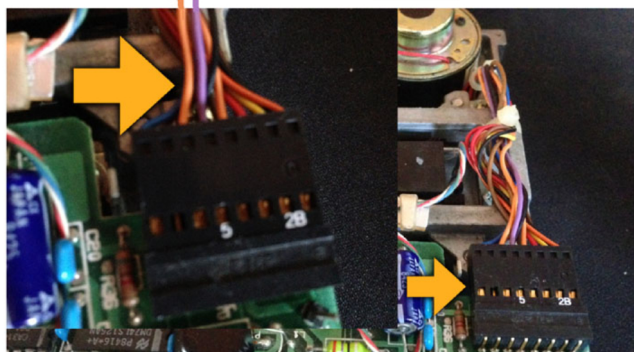
You must pay attention at the pictures at the right side and the numbers marking the cable-block! The picture shows the cable-block "twisted" around and viewing the reverse "backside"!

In case of replacing the writeprotection at the AppleIIC drive with an alternating switch you can see how to perform that task in the pictures below:
