The Basic DISK II Pages Common Mistakes and Damages to Disk II Controller or DISK II Drives **project**

The DISK II Drive - a classic storage system

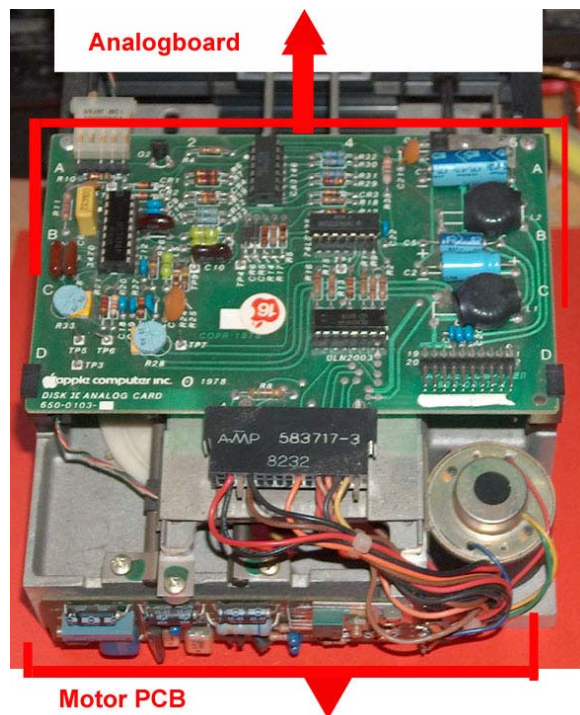
screwtop of adjustmenttrimming resistor responsible for speed

The Motor PCB contains

- the requested powerdriver electronics requested to drive the Positioning Stepper Motor and
- the power regulation electronics demanded from the Disk spinning Motor (including the speed regulation stage).

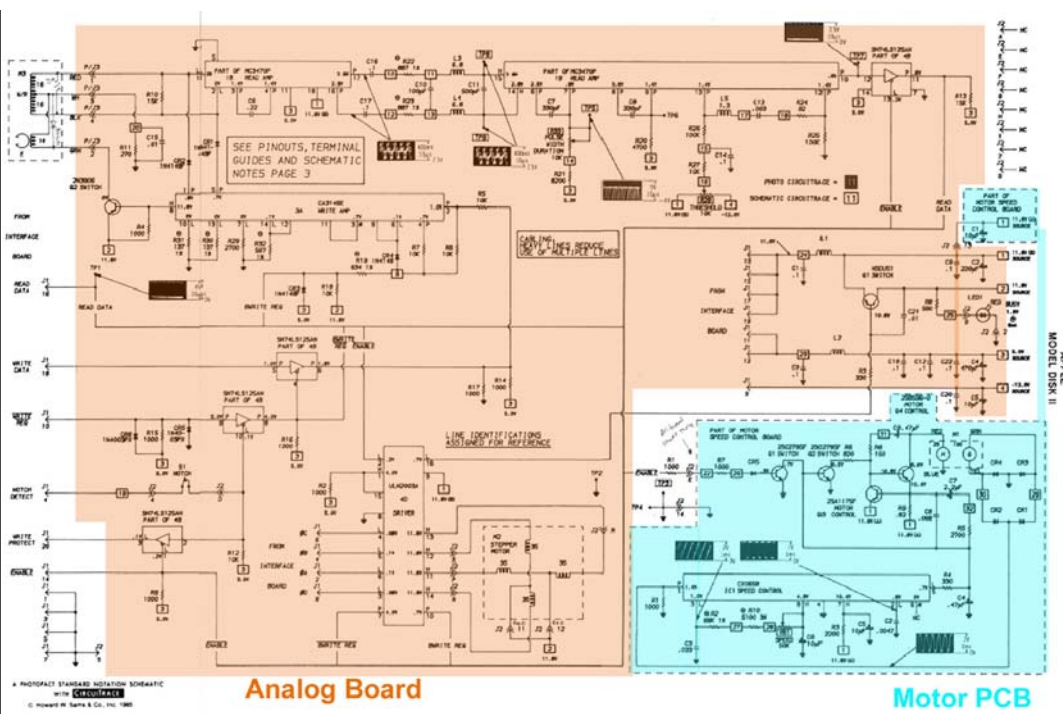
If the plugs have been misaligned for any kind of reason - we will now take a closer view to the circuitplan of the Analog board - and the Motor PCB - the parts related to the PCB are marked in the Circuitplan in same color as the PCB Name:

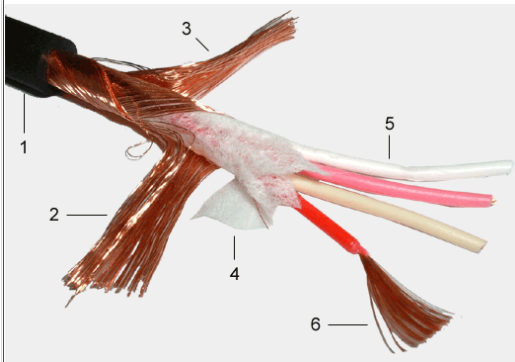
-It is even not sure that this cables will fit the needs....

- first cable seems not to be flexible enough
and second seems to fit ... - if it is thin enough
- it must be previously issued some questions to the seller:
is the "total"-cable (referring to the outer diameter of the cable)
really very thin (less 3mm) and very extreme flexible ?
