The Basic DISK II Pages

the write protection and modifications of the write protection project

The DISK II Drive - a classic storage system

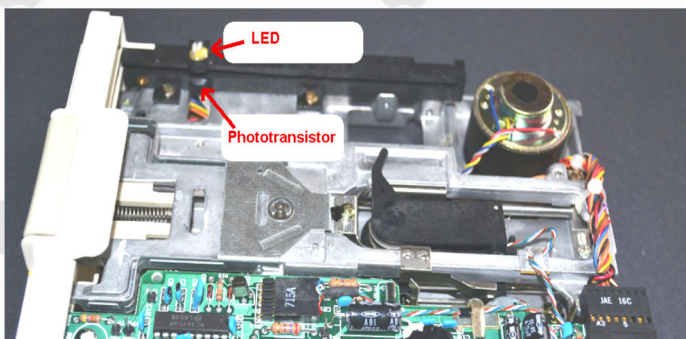
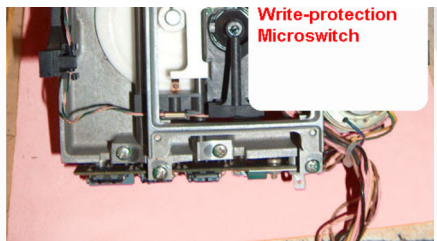
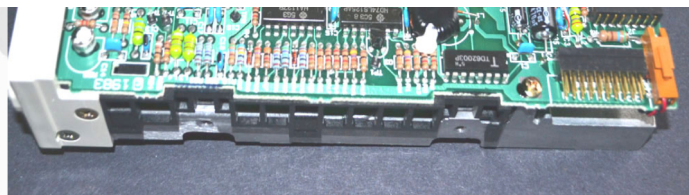
Write-protection Microswitch

In the classic DISK II drive of Apple the detection was performed by a microswitch that was located here:

The pictures below show at left a closeup of the microswitch and the detection lever and at the right picture the opposite (outside) of the steelframe is displayed to show the adjustment-screw. In case of malfunction of the write protection often the lever is misaligned and by untightening the adjustmentscrew the switch with the lever can be adjusted again in a position where the switch surely indicates again the presence of a notch or it's absence. Then the user can tighten again the adjustmentscrew in the re-adjusted position.

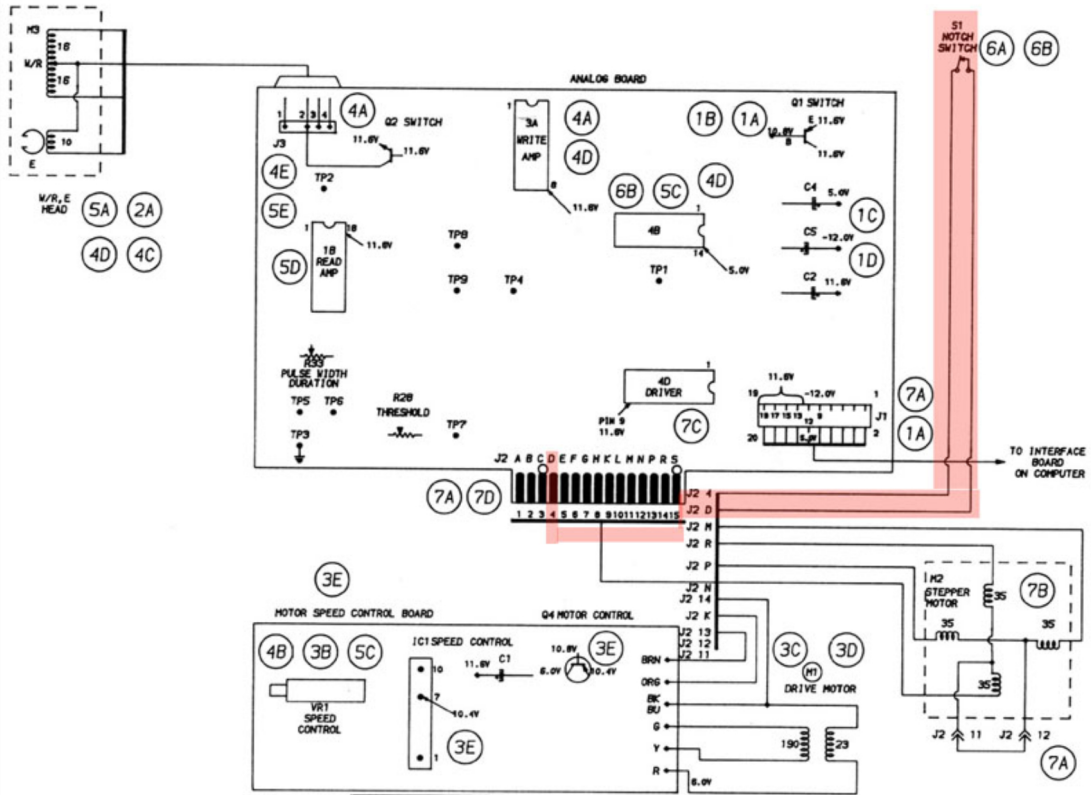
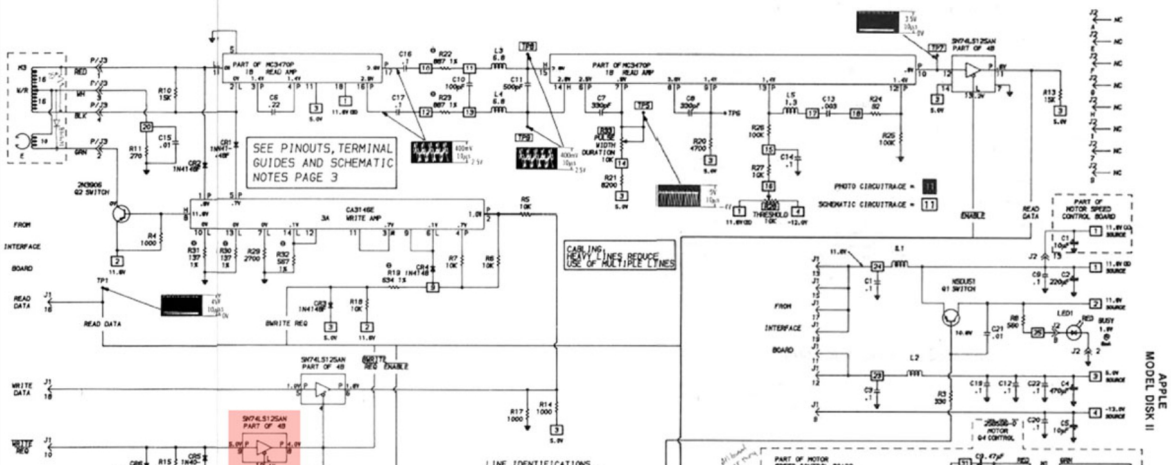
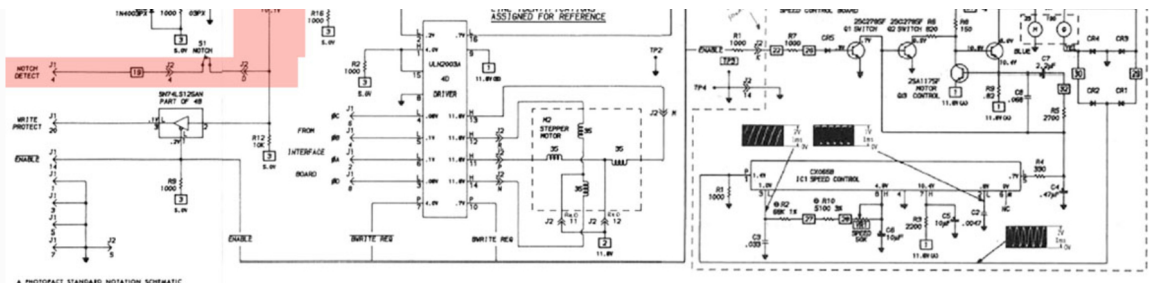
A PROTOPACK STANDARD NOTATION SCHEMATIC WITH MODIFICATIONS
© HOWARD W. SAMP & CO., INC. 1985

At the circuitplan and at Apple documentation this info's are relevant to the write protection switch (the write protection line is colored):
